## AVIATION INVESTIGATION REPORT

A01C0097

### ENGINE POWER LOSS—COLLISION WITH TREES

PIPER PA-28-140 C-FXUF

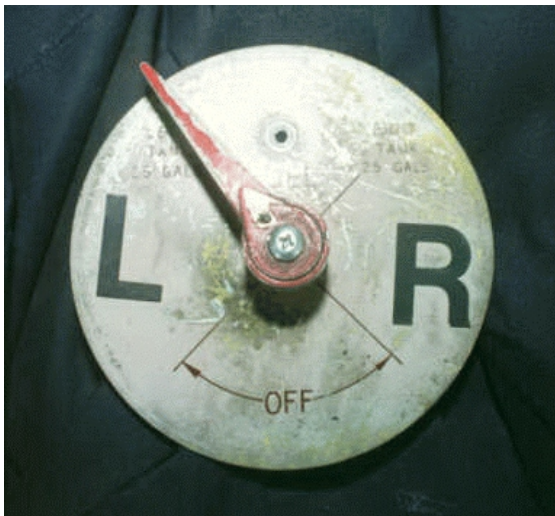
The fuel tank selector has left and right ON positions at 45° up from the horizontal and two OFF positions at 45° down from the horizontal (Figure 1). Two large letters, L and R, had been glued to the selector dial face between the OFF and ON detents on each side. The date at which these letters were installed was not determined. The fuel selector allows fuel to be drawn from either the left or right fuel cell and provides a means to shut the fuel off. Detents in the fuel selector

**Figure 1** – Fuel selector in left detent

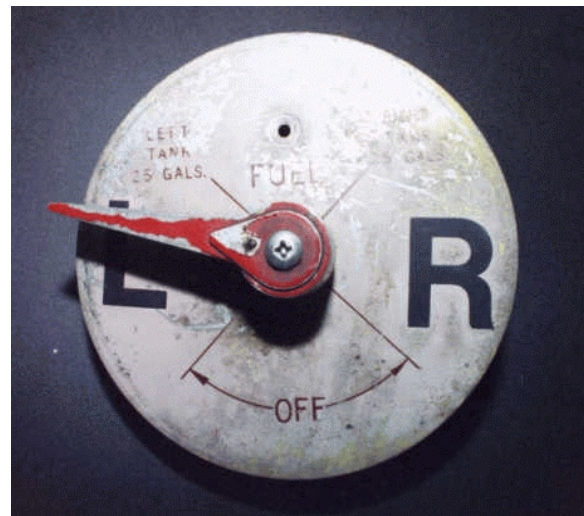
**Figure 2** – Fuel selector over L, not in detent

lines and to provide for fuel shut-off. If the selector is not positioned in the detents for the left or right fuel cell, misalignment of the galleries with the fuel lines results in a restriction of fuel flow. Placing the fuel selector dial over the L would result in fuel flow restriction to less than half of the normal flow (Figure 2). Placing the fuel selector dial in either the 12 o'clock or 6 o'clock position will result in the partial exposure of the right and left fuel galleries.

When fuel selection was made to the left tank, the selector was most likely moved over the letter L and not engaged in the left tank detent. There was enough fuel flow to continually sustain idle power and the power settings for the run-up. When power was increased during the take-off roll, the required fuel flow was only available for a limited time. The reduced fuel flow was enough for the aircraft to become airborne; however, with the continued high-power setting, the engine required more fuel than the restricted selector would allow. As a result, the engine lost power.

1. The fuel selector was most likely set to the L and not in the detent, resulting in fuel flow less than that required to sustain high engine power.
2. The engine lost power after take-off because of fuel starvation.

1. The position of the letters L and R on the fuel selector dial face did not represent accurate left or right fuel tank selections.
2. The aircraft was not equipped with shoulder harnesses. The use of a shoulder harness would probably have reduced the pilot's injuries during the forced landing.
